# Town Wide Bridge and Culvert Assessment Amherst, New Hampshire

Project No. 23.919101.01  
**May 2024**

Prepared for:  
Town of Amherst, NH

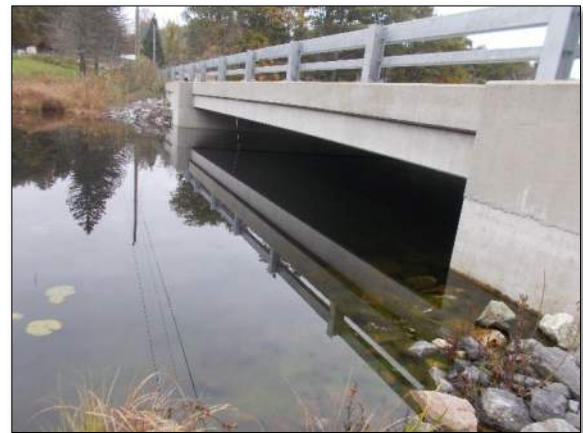
**Upstream Bridge Elevation**

The concrete deck exhibits minor vegetation growth at deck joints. The concrete deck and approach pavement are in very good condition. There is minor soil erosion behind guardrail posts. In the northeast quadrant, the approach guardrail exhibits minor scrapes and vehicular impact damage. The upstream brush curb exhibits frequent transverse hairline cracking with efflorescence. At the bridge rail posts, the hairline crack extends through the full brush curb width. The top surface of the cheek walls exhibits minor concrete scaling approximately ¼-inch in depth. At the time of observation, the water level was too high to assess the deck beams and abutment condition.

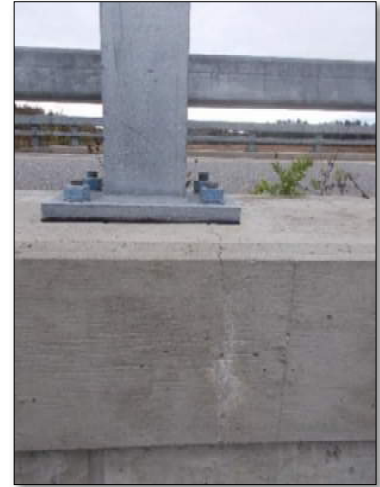
**Typical Brush Curb Cracking**

- Clean and seal cracks in brush curbs.

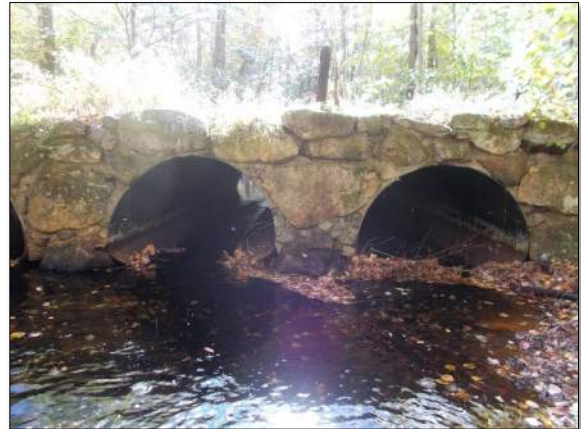
**Bridge Upstream (Northwest) Elevation**

The gravel roadway is in good condition. There is a minor sinkhole behind the upstream headwall at Barrel #2. Additionally, there is side slope / bank erosion within the northeast quadrant. Along the upstream

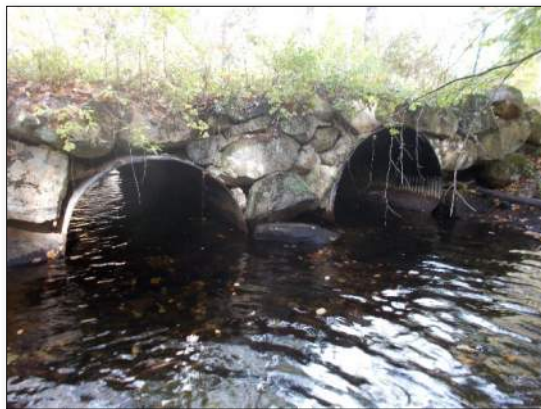
**Bridge Outlet Southeast Elevation**

side, all three barrels are undermined by up to 6" deep for 2' to 4' along the length of the culvert. Barrels #1 to #3 have 6", 1', and 1' scour depths at the upstream pipe inverts, respectively. The upstream headwall exhibits voids along the edge of each barrel. On the downstream side, the headwall stones have settled and shifted downward between 2.5" to 5", especially at Barrel #2 which is noticeably lower than Barrels #1 and #3. The east end of the downstream headwall has a large 3' by 4' void assumed to have been caused by a missing headwall stone. The downstream channel exhibits some aggradation with sand build up between the barrels.

Each CMP barrel has an internal bituminous coating that has failed at and below the waterline. There is also moderate rusting and corrosion at the pipe inverts and sagging in the crown of the CMPs near roadway centerline.

The field observations made for this Report show that the existing bridge is likely in Poor (4) Condition as compared to the Fair (5) Condition Rating in the latest NHDOT Bridge Inspection Report.

- Place grout bags or cutoff walls along the upstream inverts to alleviate further undermining.
- Re-point stone masonry headwalls.
- Repair the southeast headwall void.
- Remove vegetation from the headwalls.

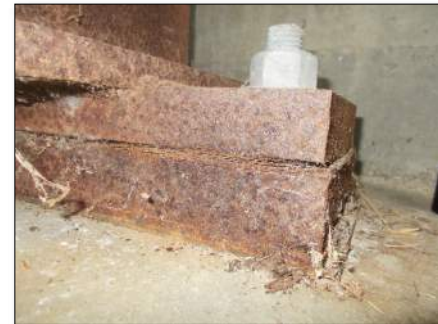
The bridge and approaches have been recently repaved and are in excellent condition. The bridge exhibits light cracking on top of the brush curbs and deck soffit with minor efflorescence on the deck soffit at the northwest corner. Five of the seven posts on the eastern bridge rail have scrape or gouge damage. Two posts are bent, and the underside of the top aluminum rail in the northeast quadrant exhibits a gouged hole. In the southeast quadrant, the approach guardrail has a missing offset block. In the southwest quadrant, the approach guardrail has a split wood offset block. There is minor spalling on top of the northwest and southwest wingwalls with delamination occurring at the northeast wingwall. Otherwise, the concrete is sound. The steel stringers are in good condition. Corrosion has initiated at the north end of the eastern most beam. The bearing at this location exhibits laminar corrosion between the sole and masonry plate. Otherwise, there is minor surface corrosion on all bearings.

Northeast Fixed Bearing  
Laminar Corrosion

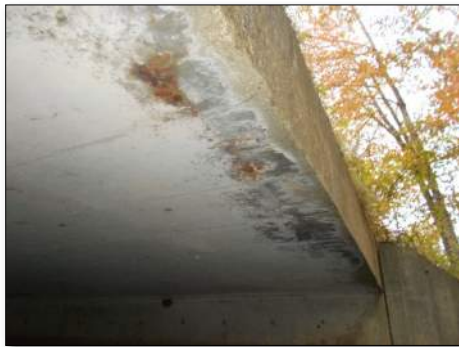
**Cracking with Rust Staining  
on Slab Soffit**

- Repair deteriorated concrete on the headwalls and slab soffit.

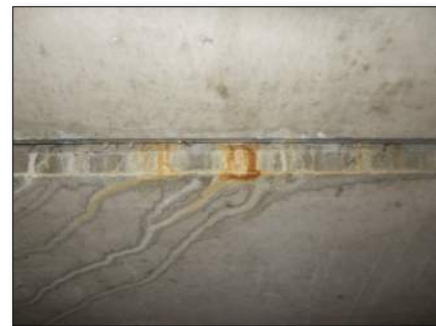
**Rusting and Efflorescence in  
Prestressed Deck Beam Joint**

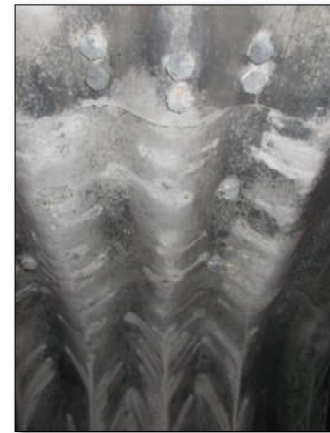
The bridge and approach pavement are in good condition with sealed longitudinal cracks. The guardrail is substandard and has decayed timber posts, insufficient height, and insufficient end terminals in addition to minor scrapes and impact damage. The aluminum plates along the sides and top of the box culvert exhibit multiple small corrosion holes with efflorescence and water seepage in the middle of the box culvert. Based on research completed by Hoyle Tanner, this corrosion is likely caused by an electrochemical reaction between the aluminum, the bridge backfill, and moisture. There are some gaps between upstream headwall plates and the box culvert plates. The outlet apron is undermined across the entire culvert width. The box culvert is perched 1' above the natural channel causing a hydraulic drop. The northeast and northwest wingwalls are out of plumb and lean towards the waterway.

**Corrosion in Box Culvert  
Plates at Roadway Centerline**

- Installing a sacrificial zinc anode to provide cathodic protection for the aluminum. Based on discussion with corrosion specialists, an effective cathodic protection technique for this bridge would be to clean the corrosion from the inside of the box culvert and apply a zinc rich paint to the interior face of the box culvert sheeting. The zinc will act as a galvanic anode to provide cathodic protection for the aluminum.

- Installing an impervious waterproofing membrane within the bridge backfill to prevent water from accessing the soil and aluminum interface. Water is required for electrochemical corrosion.

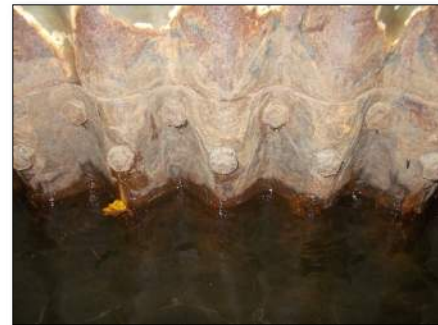
Culvert Corrosion in Eastern Barrel

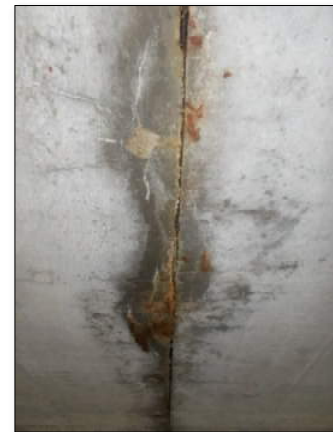
**Top Slab Construction Joint**

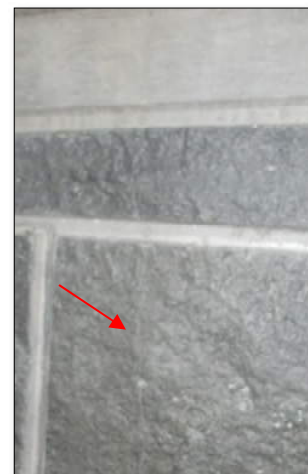
**Vertical Hairline Cracking in  
North Abutment**

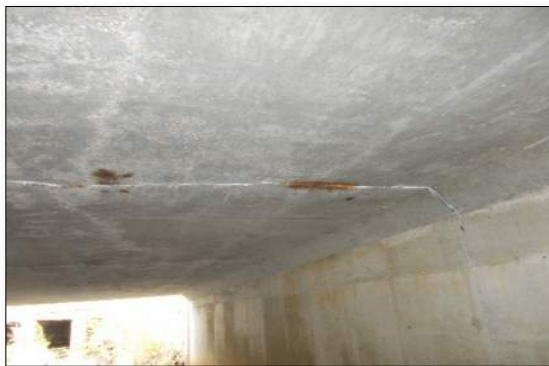
**Cracking with Efflorescence and Rust Staining on Top Slab Soffit**

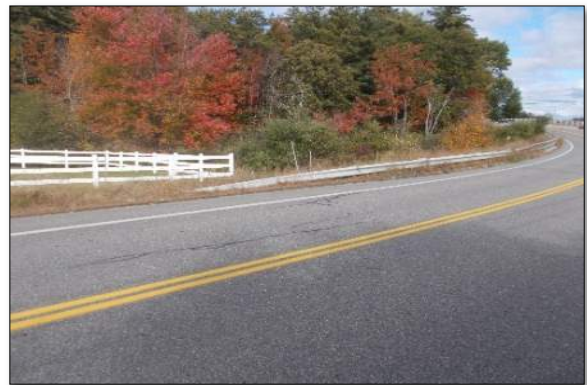
Minor horizontal sealed cracking was observed on the pavement with no other defects to the wearing surface noted. The northwest quadrant exhibits 1 ½" of settlement measured at the curb. Several wooden approach rail posts are rotten or broken on the northwest and southwest approach. Additionally, the northwest and southwest approach rail has substandard "tip down" end treatments. The northeast and southeast approach posts are constructed from galvanized steel. The top slab fascia at the upstream side exhibits minor cracking with efflorescence at the center pier between box culvert cells. The silicone joint sealant has failed at all four wingwall to box culvert joints. A beaver dam was observed at the outlet of the east box culvert cell. Local scour observed immediately upstream of the east box culvert cell, however, there were no signs of box culvert undermining.

**Northwest Approach Rail "Tip Down"**

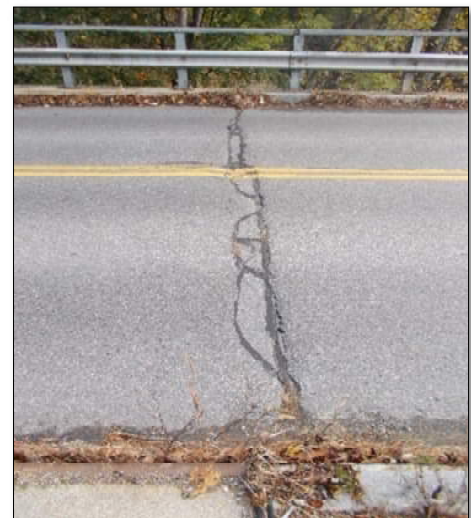
**North Asphaltic Plug**

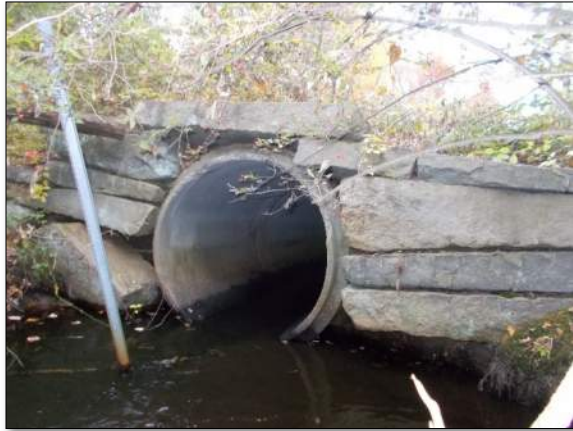
**Culvert Outlet Elevation**

The headwalls are in poor condition. Both headwalls have voids up to 1.5' deep throughout. The inlet headwall backfill is encapsulated with geotextile fabric; however, the outlet headwall backfill is not. At the outlet, the headwall is missing base stones causing settlement of the stones. The voids at the outlet are up to 4' deep.

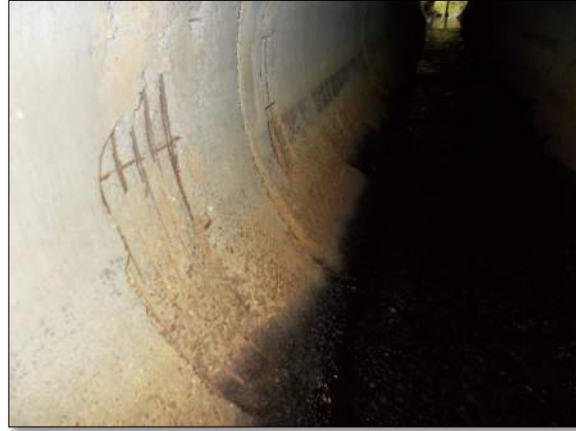
**Spalling at the Culvert Outlet**

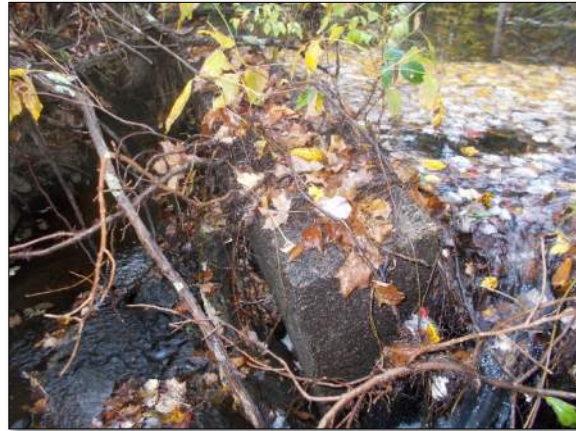
**Private Dam Immediately Upstream of the  
Culvert**

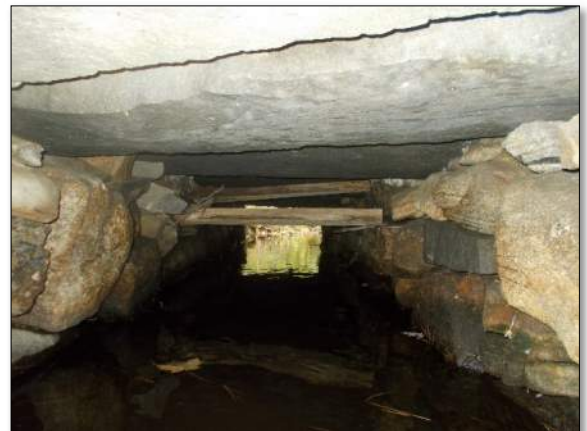
The north roadway edge is eroding due to the lack of a headwall at the culvert inlet. There are likely some voids between the stones that comprise the culvert walls, but there were no signs of roadway settlement or roadway fill in the brook which would indicate that soil is migrating through the voids. Timber bracing was observed at the center of the culvert.

**Culvert Interior Looking Downstream**

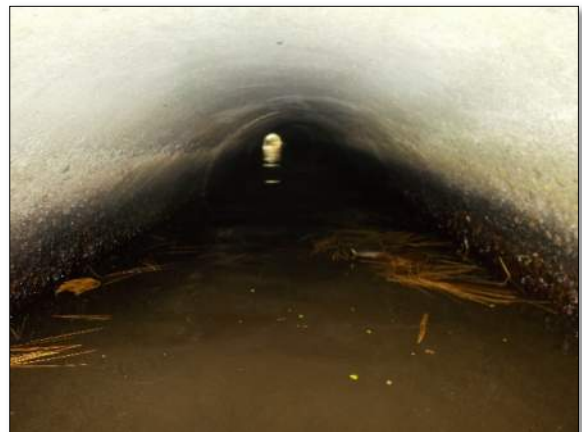
**Culvert Misalignment**

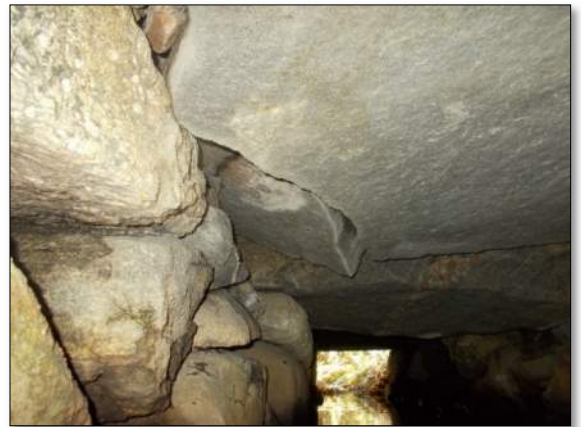
**Top Slab Split at Culvert Inlet**

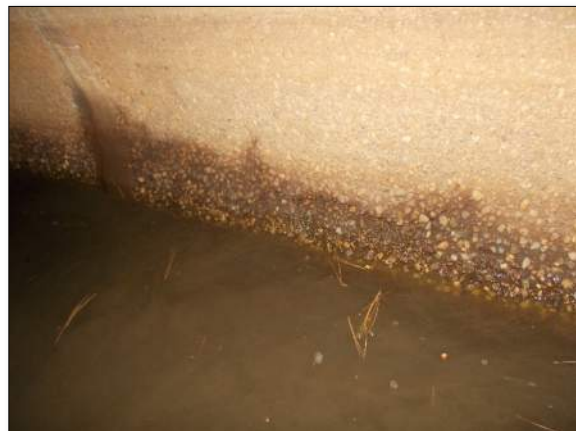
The RCP is in satisfactory condition. There is significant abrasion at the spring line and spalling with exposed reinforcing steel at the culvert outlet.

**Abrasion At Spring Line**

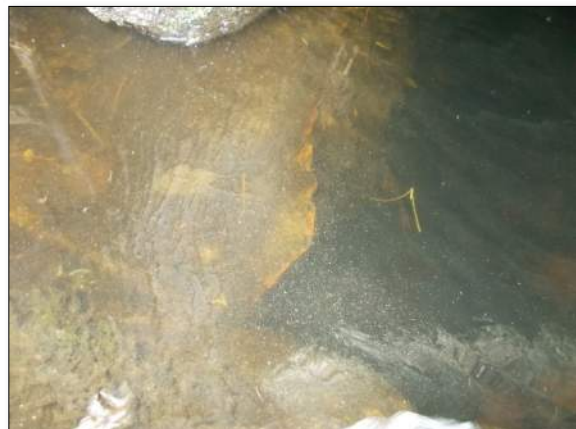
**Submerged CMP at Outlet**

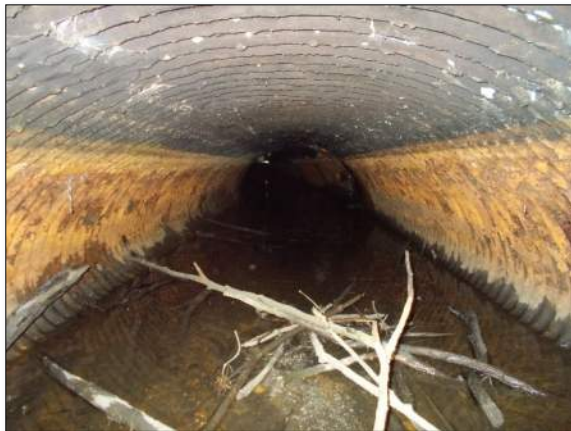
**Typical Culvert Condition**

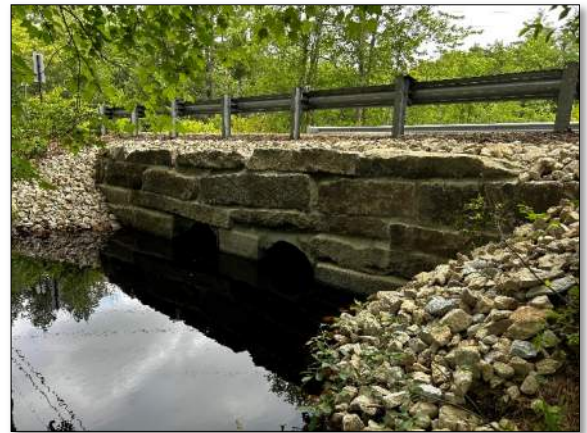
**Downstream Headwall**

The CMPs exhibit significant rusting and section loss up to 100% along the spring line for 3' along the inlet and outlet of the culvert. The channel is comprised of soft organic soils overlaying sand and gravels. The upstream and downstream banks are armored with riprap for approximately 5' beyond the limits of the headwall.

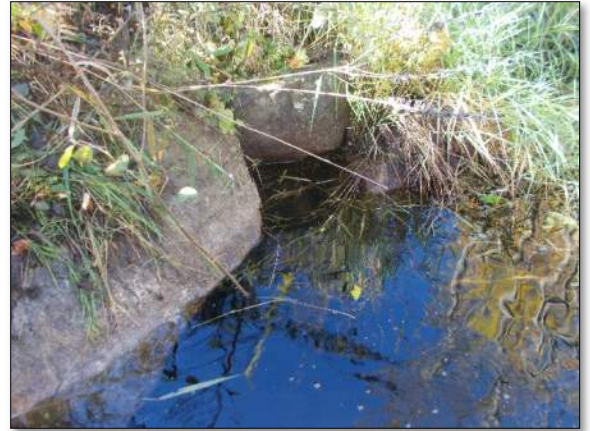
**Culvert Inlet at Collapsed Headwall**

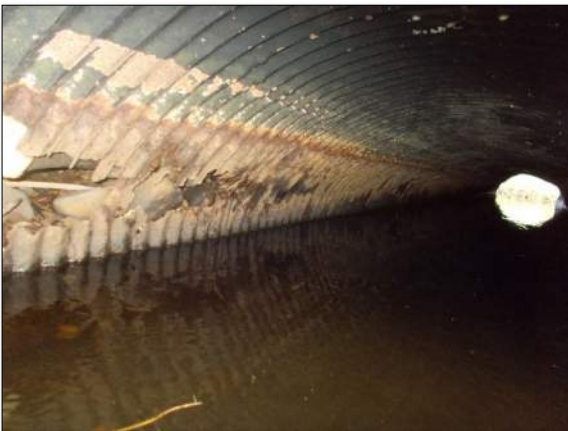
#### **100% Section Loss At Culvert Outlet**

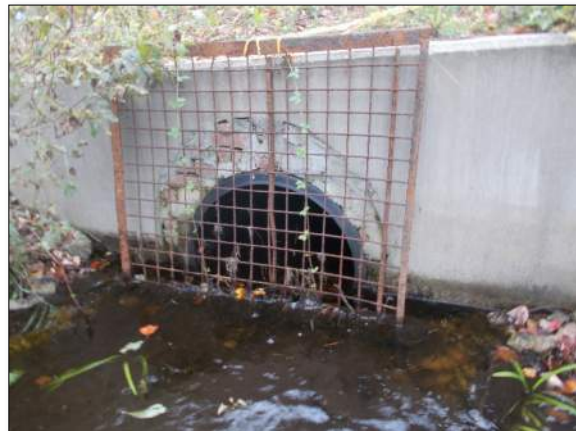
**Culvert Outlet Elevation**

The headwalls are in good condition. The outlet exhibits locations of mortar patching failure between the precast culvert opening and the HDPE pipe. The side slopes around the headwall exhibit bank erosion. The inlet headwall mortar patching is cracking. The inlet headwall exhibits bank erosion around each side of the headwall.
