A brief description of the condition of the Parker Cooper's Shop

Parker Farm LN Open Space Baboosic Lake Road; Amherst, NH 03031. November 5, 2020

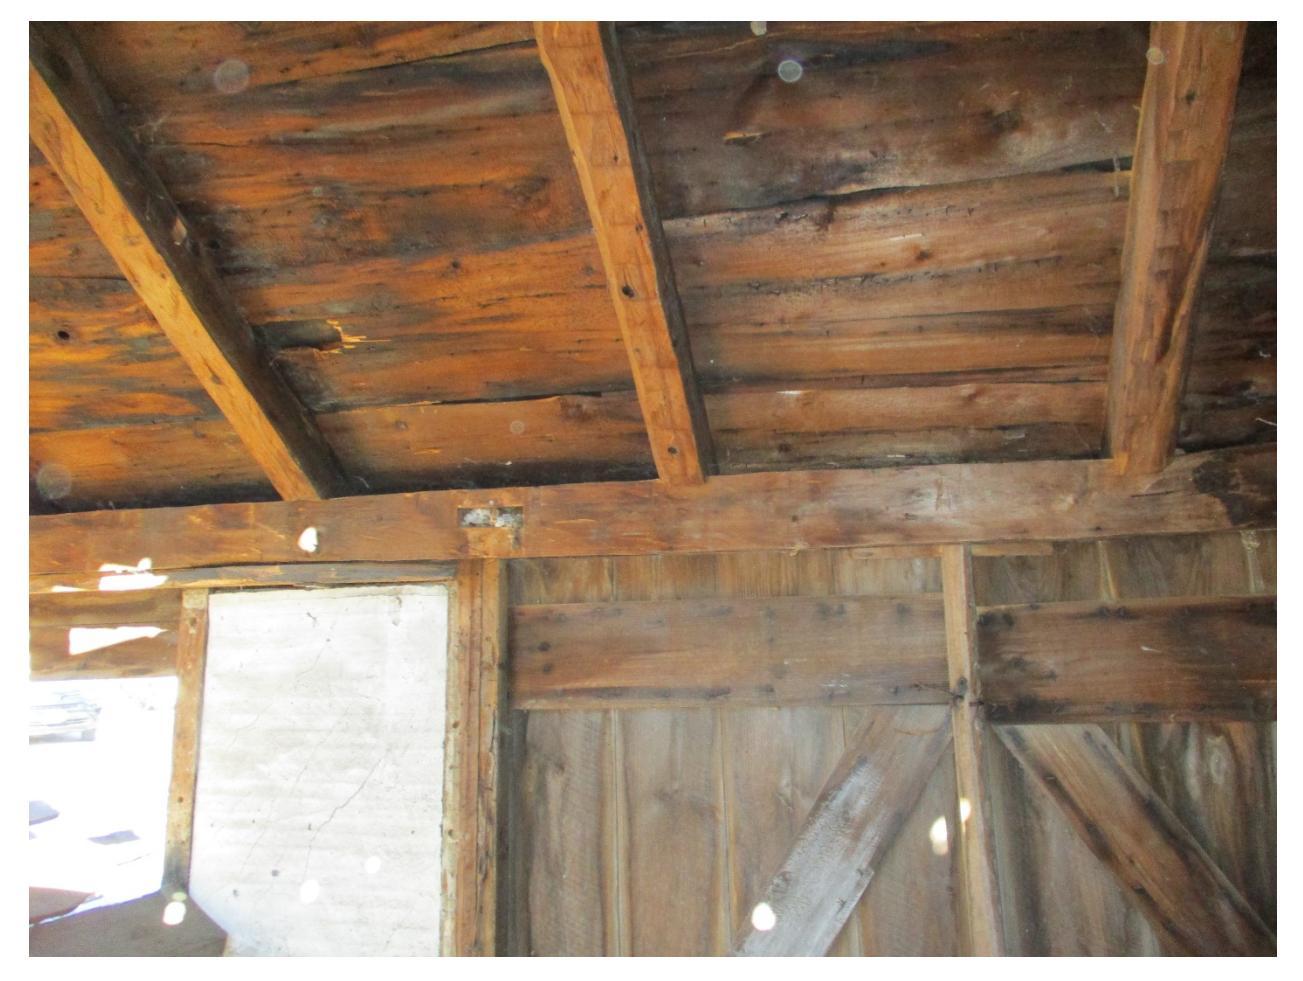
North (roadside) hewn plate and rafters with original roof sheathing.

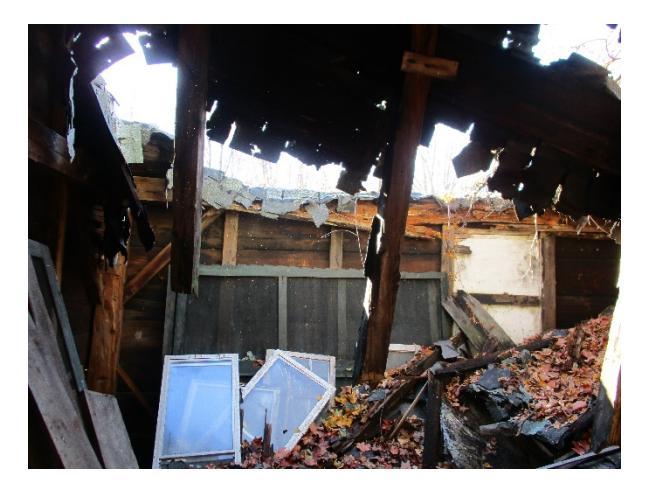
The present condition of the building is poor. The rear roof has fallen in due to a leaking roof that over time rotted the rear plate causing the rear rafters to collapse.

South rafters collapsed

If the building is to be saved, there must be immediate action before the winter season to stabilize the structure from further deterioration by constructing a temporary rear roof to protect the remaining fabric. This could be a simplified roof constructed with dimensional lumber and plywood or sheet metal roofing.

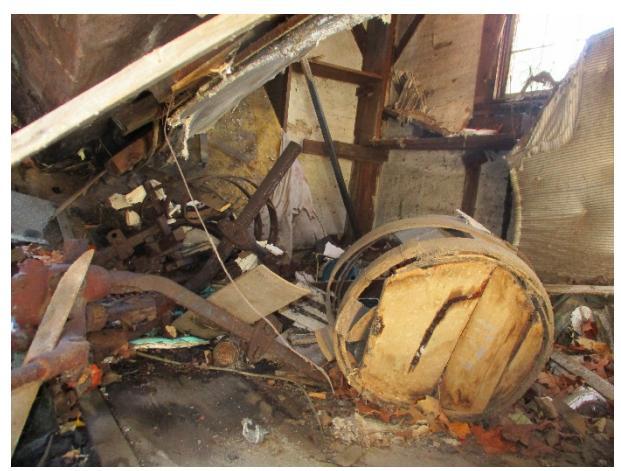
Remains of coopered ware

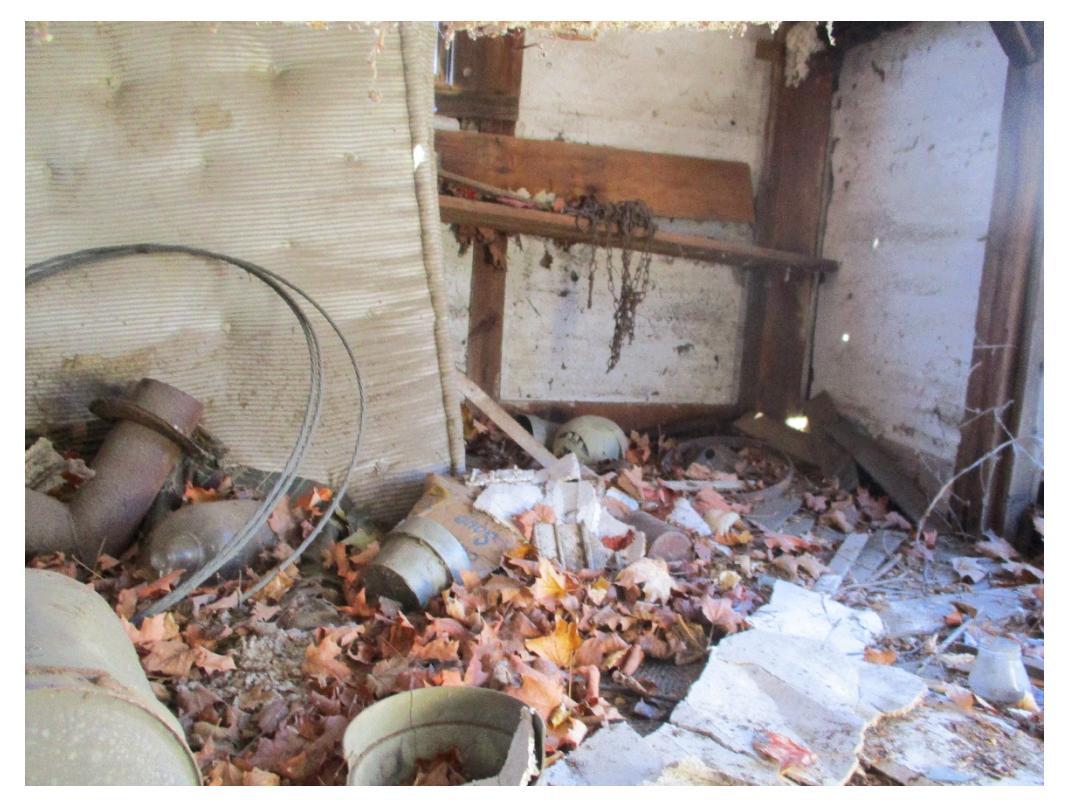
South west corner showing plaster between studs

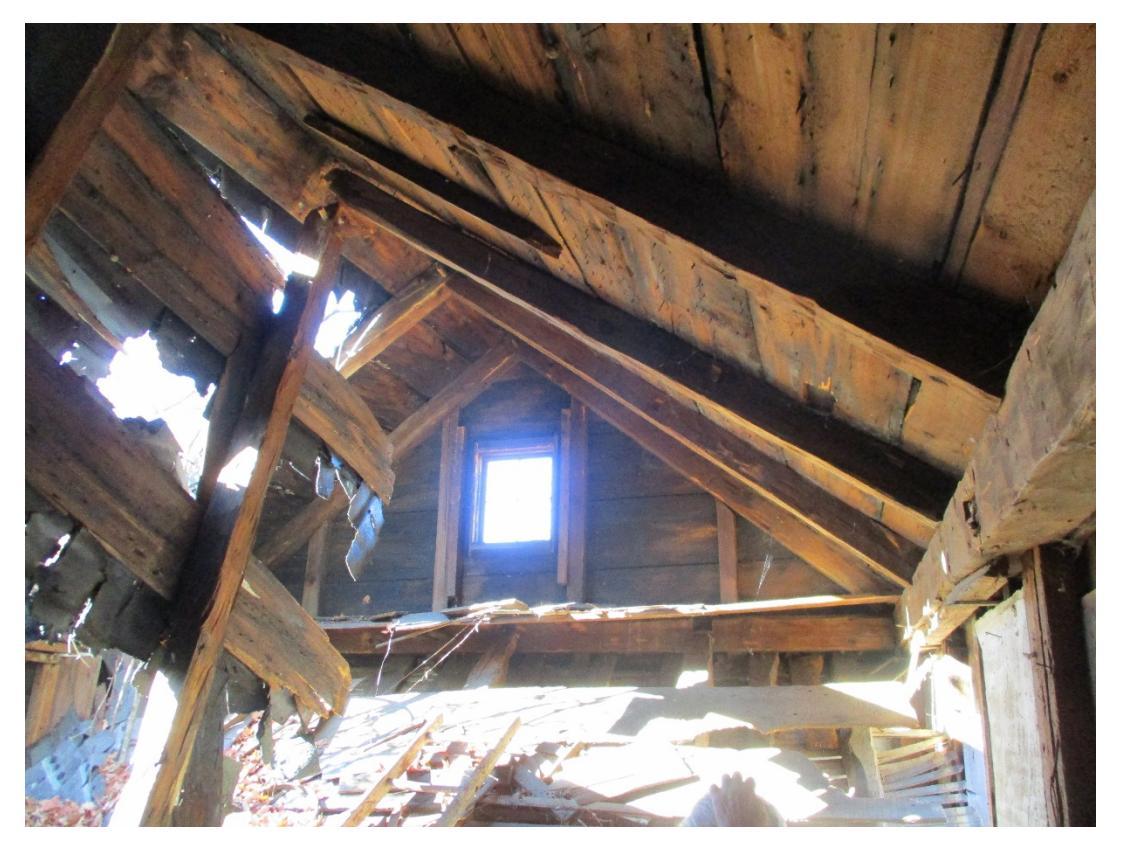
West gable end showing collapsed plaster ceiling and roof

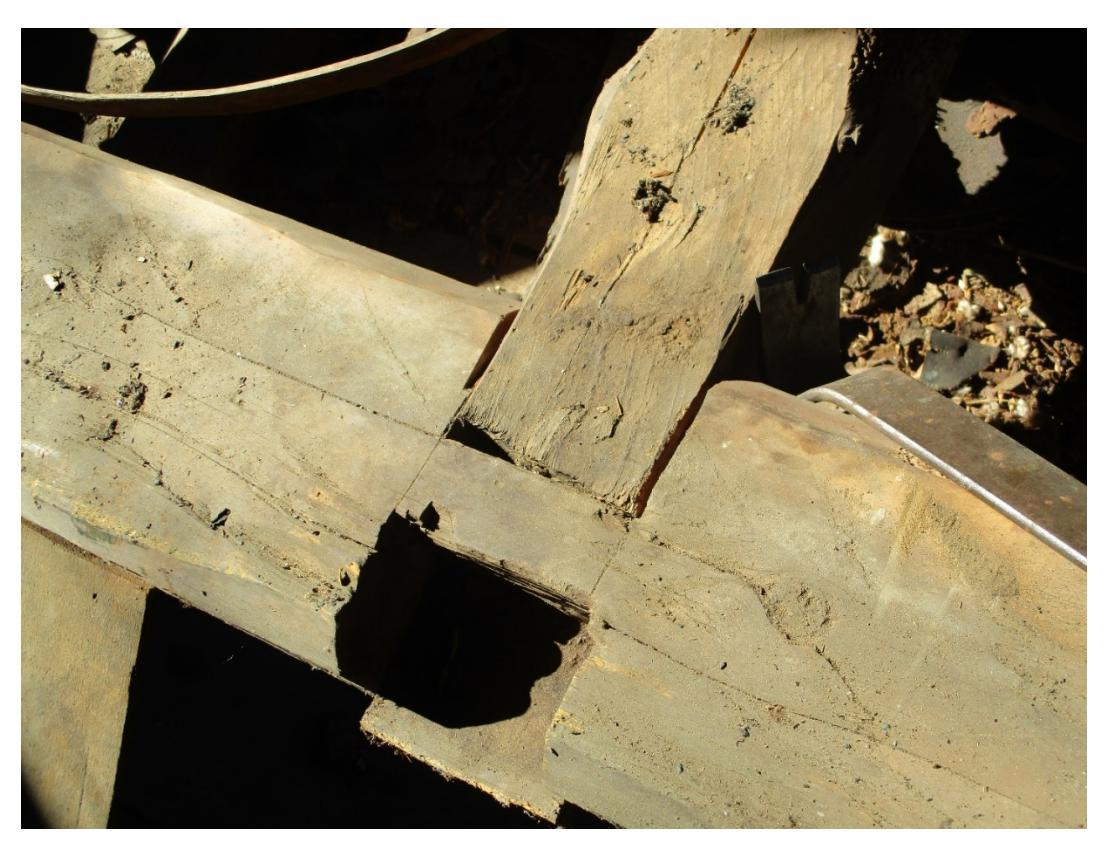
Typical hewn attic floor joist cog joint

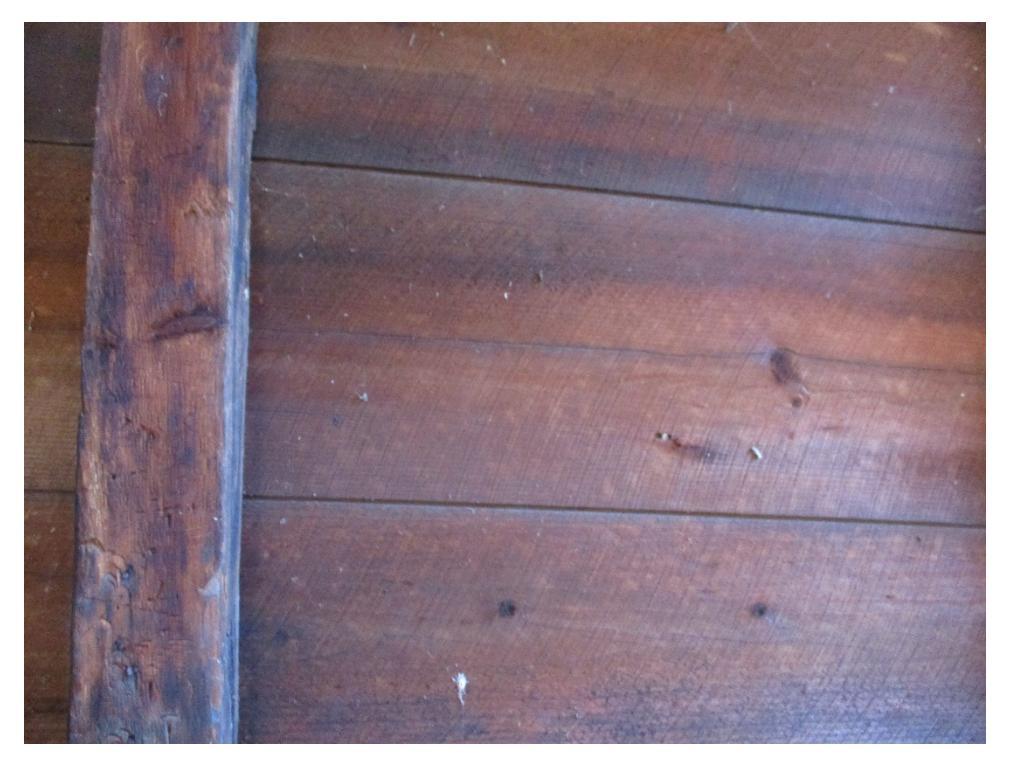
20th century circular sawn sheathing (East end)
