# Town Wide Bridge and Culvert Assessment Amherst, New Hampshire

Project No. 23.919101.01  
**May 2024**

Prepared for:  
Town of Amherst, NH

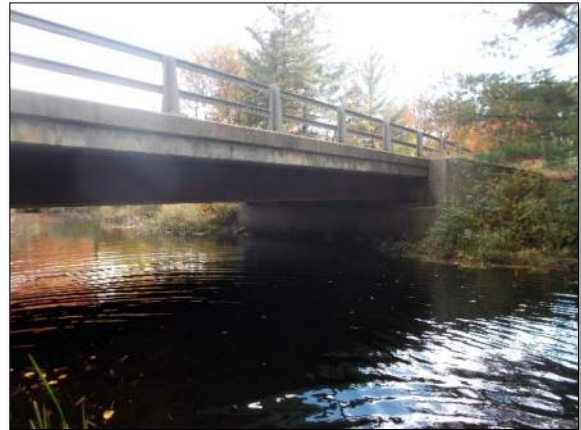
Bridge Inlet Elevation

The bridge and approaches have been recently repaved and are in excellent condition. The bridge exhibits light cracking on top of the brush curbs and deck soffit with minor efflorescence on the deck soffit at the northwest corner. Five of the seven posts on the eastern bridge rail have scrape or gouge damage. Two posts are bent, and the underside of the top aluminum rail in the northeast quadrant exhibits a gouged hole. In the southeast quadrant, the approach guardrail has a missing offset block. In the southwest quadrant, the approach guardrail has a split wood offset block. There is minor spalling on top of the northwest and southwest wingwalls with delamination occurring at the northeast wingwall. Otherwise, the concrete is sound. The steel stringers are in good condition. Corrosion has initiated at the north end of the eastern most beam. The bearing at this location exhibits laminar corrosion between the sole and masonry plate. Otherwise, there is minor surface corrosion on all bearings.

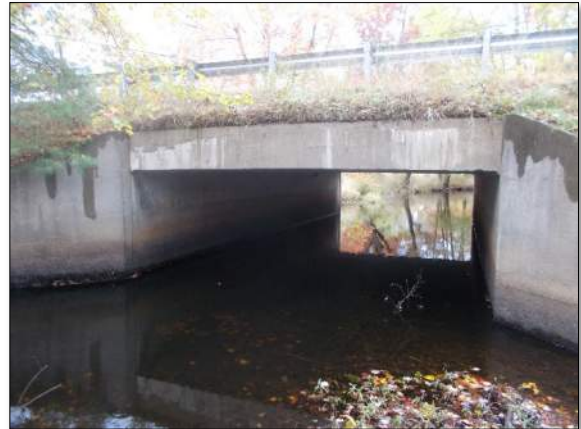
**Bridge Upstream Elevation**

The roadway pavement is in good condition. At the time of observation, there was ponding on the eastern shoulder. In the northeast and northwest quadrants, the approach guardrail exhibits minor scrapes and vehicular impact damage. The western culvert headwall exhibits light cracking with moderate efflorescence. The deck slab soffit edge exhibits concrete cracking with rust staining and minor delamination below the upstream and downstream headwall. On the eastern edge, the bottom of the top slab has two additional spalls. The concrete frame legs and wingwalls exhibit hairline cracking and minor abrasion at water level. There is no joint sealant between the frame and the wingwalls.

- Repair deteriorated concrete on the headwalls and slab soffit.

- Replace damaged guardrail.
- Place silicone joint sealant in the frame-to-wingwall joints.

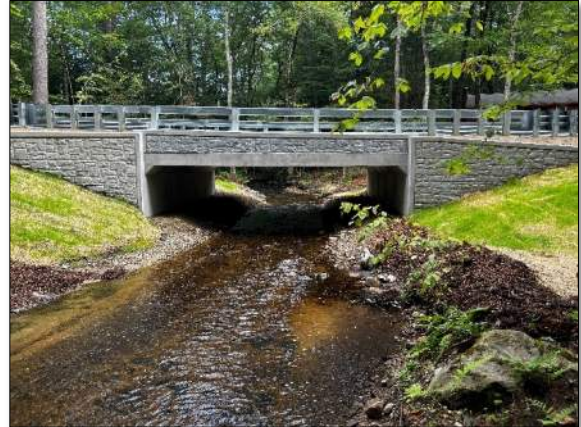
**Bridge Inlet Elevation**

Site observations of this bridge were not included in the scope for this project since the bridge was replaced in 2023 (see Section 1.4). The NHDOT Bridge Inspection Report does not include any observed deficiencies.

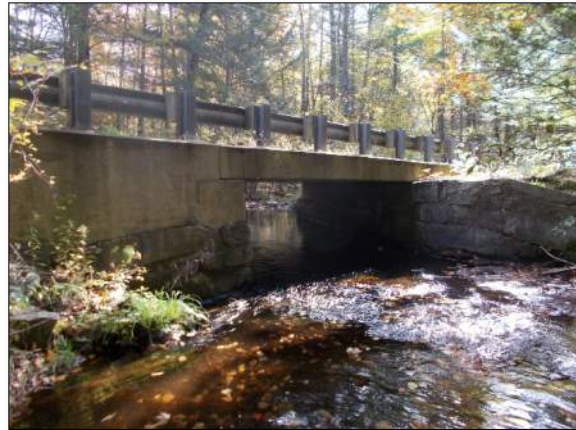
**Bridge Inlet Elevation**

The bridge and approach pavement are in good condition. Some pavement cracking was observed at the south deck end. Longitudinal pavement cracks were observed and have been sealed. The brush curbs exhibit minor cracking, with debris and vegetation growth along the gutter line. The bridge guardrail is substandard. The approach guardrail is substandard and does not have crash-worthy end terminals. The guardrail and bridge rail have scrapes and minor deformations throughout. The post-tensioning ducts along the deck beam fascia has minor cracking with efflorescence. The joints between adjacent deck beams exhibit signs of leaking as efflorescence and rust staining were observed throughout. The substructure, comprised of mortared stone masonry with cast-in-place concrete caps, is in good condition.

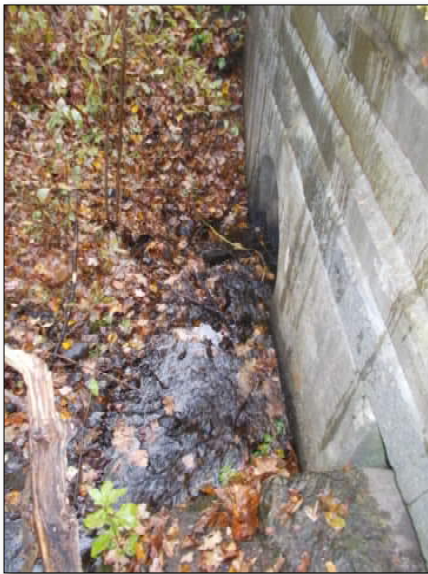
**Culvert Inlet Elevation**

The roadway has recently been paved and is in excellent condition. The guardrail is in excellent condition. The guardrail does not have crash-worthy end terminals.

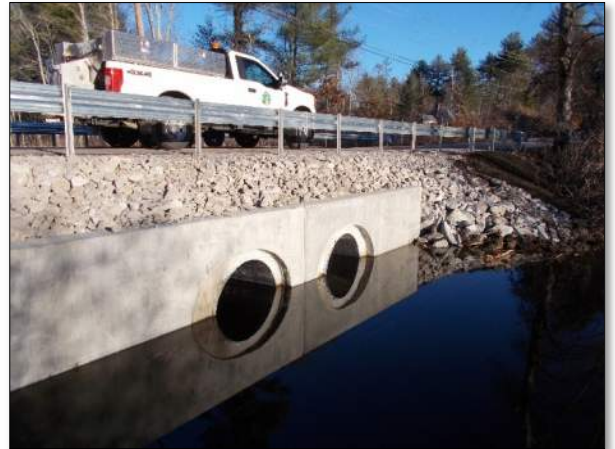
**Culvert Outlet Elevation**

Overall, the culvert is in Excellent (9) condition.

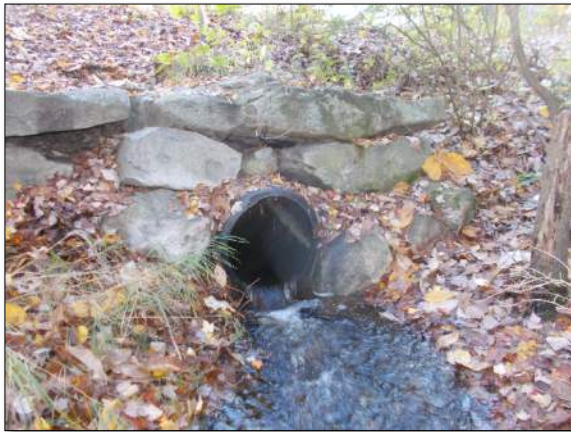
### **Culvert Outlet**

The pavement is in good condition. The roadway side slope at the inlet is steep and there are locations of erosion despite the side slope being heavily vegetated. The outlet headwall is in fair condition. The wall is stable with no signs of settlement or shifting; however, large voids between the stones were observed.

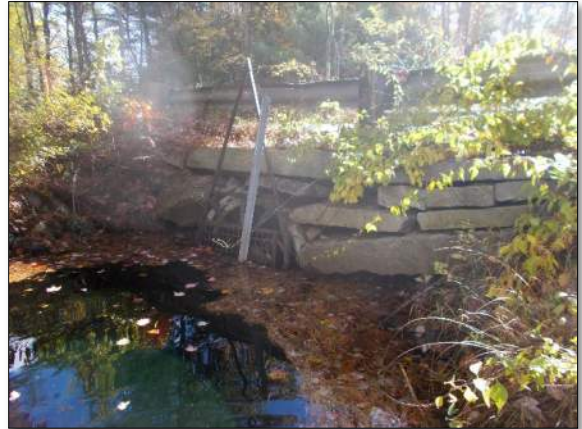
The pavement is in satisfactory condition with sealed crack above the culvert centerline as well as some pavement depressions in the northern lane. The guardrail has scraping and impact damage throughout as well as missing posts.

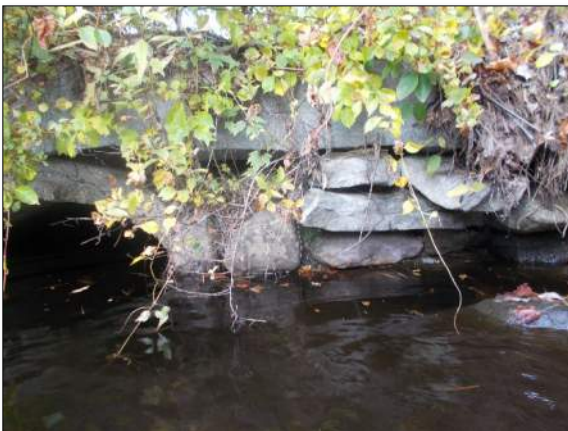
### **Culvert Inlet Elevation**

thalweg. The outlet has a 1' deep scour hole.

Overall, the culvert is in poor (4) condition.

The headwalls are in poor condition. Both headwalls have voids up to 2.5-feet deep throughout. Additionally, the inlet headwall shows signs of settlement and is leaning towards the waterway. A beaver screen was observed at the culvert inlet. There is significant vegetation on top of the outlet headwall.

The RCP is in fair condition. There is exposed reinforcing and spalling at the inlet and outlet, primarily at the crown. The RCP exhibits moderate abrasion at and below the waterline. There is excess beaver dam debris in the pipe at the inlet.

- Replace the existing guardrail and add install crash-worthy end terminals.
- Chink the headwall voids.
- Fill in the channel scour holes.

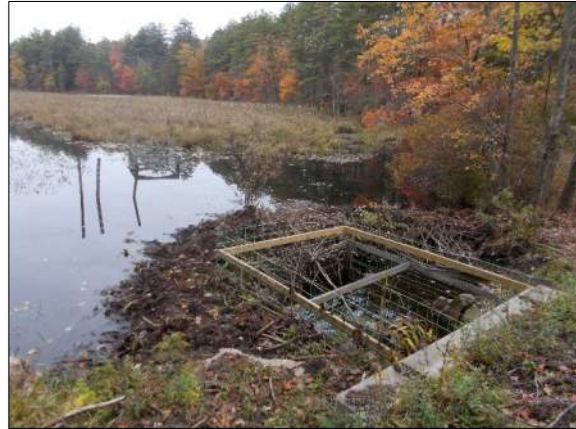
**Culvert Upstream**

The headwalls are in good condition. The outlet exhibits locations of mortar patching failure between the precast culvert opening and the HDPE pipe. The side slopes around the headwall exhibit bank erosion. The inlet headwall mortar patching is cracking. The inlet headwall exhibits bank erosion around each side of the headwall.

The HDPE pipe exhibits sagging at midspan but is otherwise in good condition.

Overall, the culvert is in good (7) condition.

- Maintain beaver deterrents.
- Replace the cracked or missing mortar around the HDPE as required.
- Inspect culvert on a biennial basis.
